# Lab Test

## WEATHERFORD SCALING TESTS

Filename: LabTest Weatherford.pdf

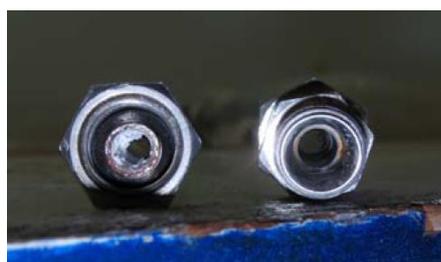
Figure 1 The scaling of an untreated pipe (left) compared to a pipe treated with Hydropath (right) (page 10).

The difference in the amount of scale formed on the pipes with and without Hydropath was observed visually. Not only was there significantly more scale on the untreated system, but it could easily be seen that the scale was hard and required manual scraping, unlike in the treated system, where the deposits were soft, powder-like and easily brushed away.
