MV Hoegh America – Pilot experiment Report

On the use of a HydroPath **MARINE** equipment on a Fresh Water Generator unit

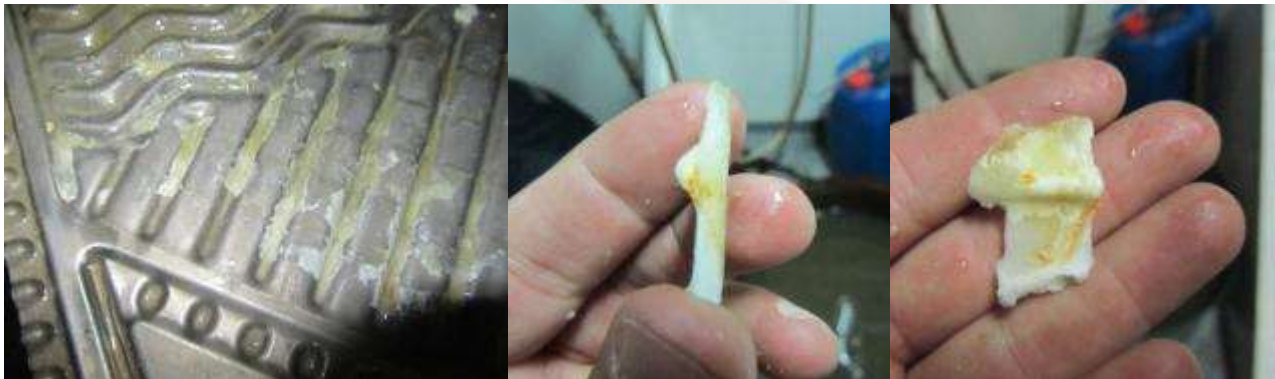
The FWG was treated with chemicals (Liquidewt) on a regular basis by dosing pump, as instructed by the ship managers. Despite that, on most plates of the heat exchanger, it was found that there was a built-up of lime scale, up to 3 mm thick (figure 2).

Figure 2.Limescale precipitation on the titanium heat exchanger plates prior to the installation.

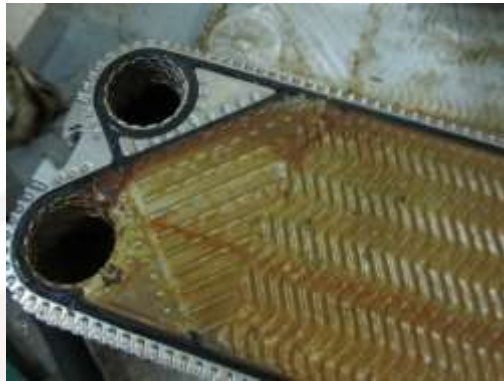
Figure 3.FWG plates while opening covered with slime

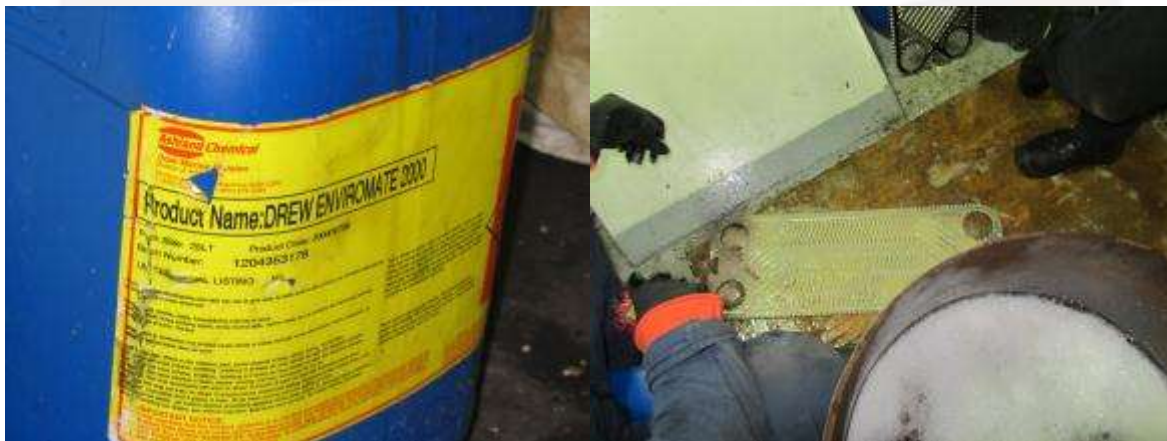
1. Plates are dipped in a chemical (Drew Enviromate 2000) and brushed to remove soft dirt and slime (figure 4).
2. Plates are dipped in a chemical (Liquidwt) to soften the limescale, which is later being carved out with a sharp ended tool made of a copper pipe (figure 5).

Figure 4.Left: Drew Enviromate 2000 – multipurpose cleaning. Right: Plate is brushed to remove dirt.

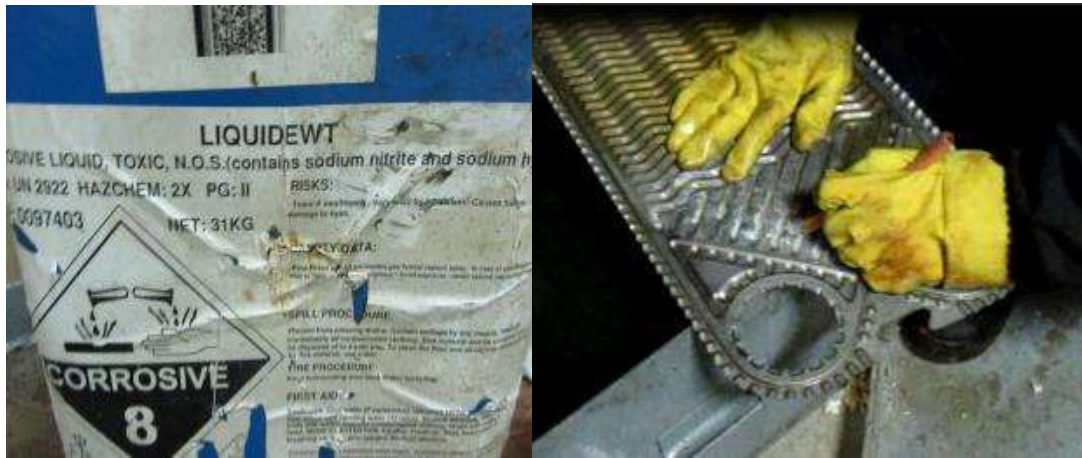
Figure 5.Left: Chemical used to soften limescale. Right: Carving out limescale

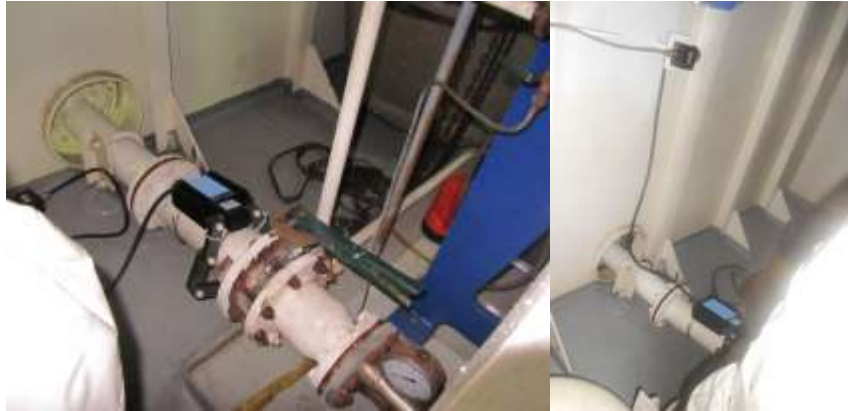
The HydroPath MARINE unit was installed on a 4" pipe, providing sea water to the FWG, approximately 1 meter before the inlet to FWG.

The system was installed slightly backwards from where it should have been placed, in order to protect it from wetness, whilst opening the FWG. The system is connected to an EJB connection/ junction box as seen on figure 6. The EJB connection/ junction box is connected to the main power cabinet of the FWG as seen in figure 7.

Figure 6.Left: System experimental installation location. Right: System is connected to an EJB connection.

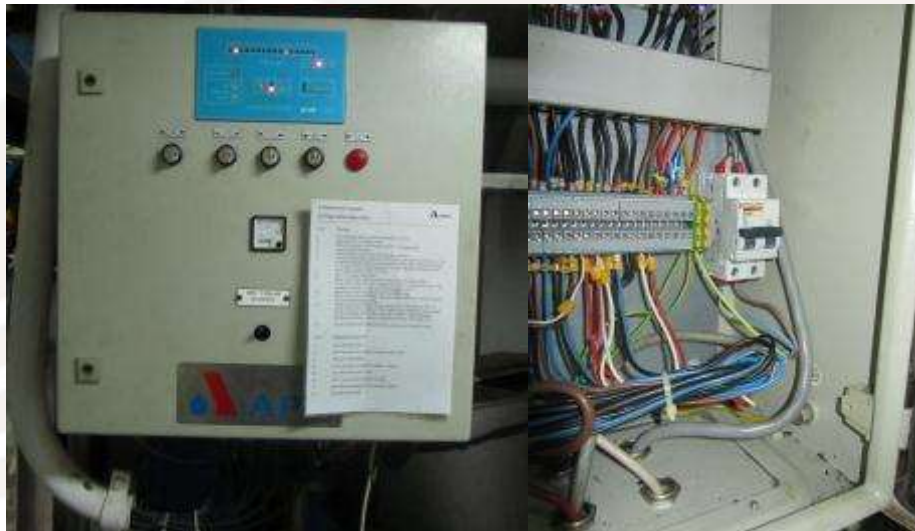
Figure 7.FWG main power cabinet and cable connection

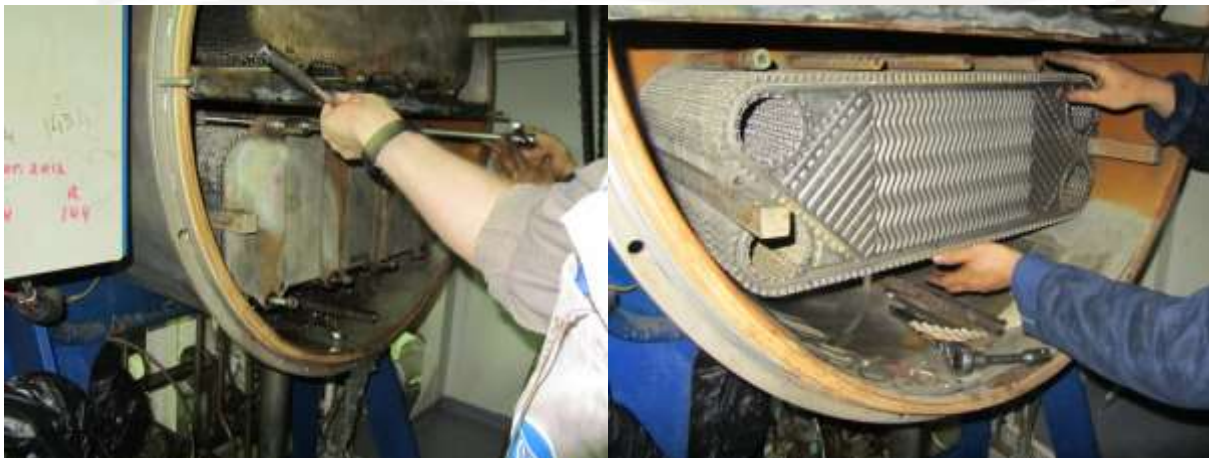
3. When the FWG cover was first unscrewed, the water which was released was very clear with no mud or signs of murkiness.
4. Most of the plates were found clean and had no limescale built-up on them. On several plates, there were areas of very loose limescale built-up, which was easily removed with a gentle hand touch or shake off of the plate and without any chemicals or carving process (as seen on figure 9).

Figure 8.System is opened and cover is removed. Water released is clear.

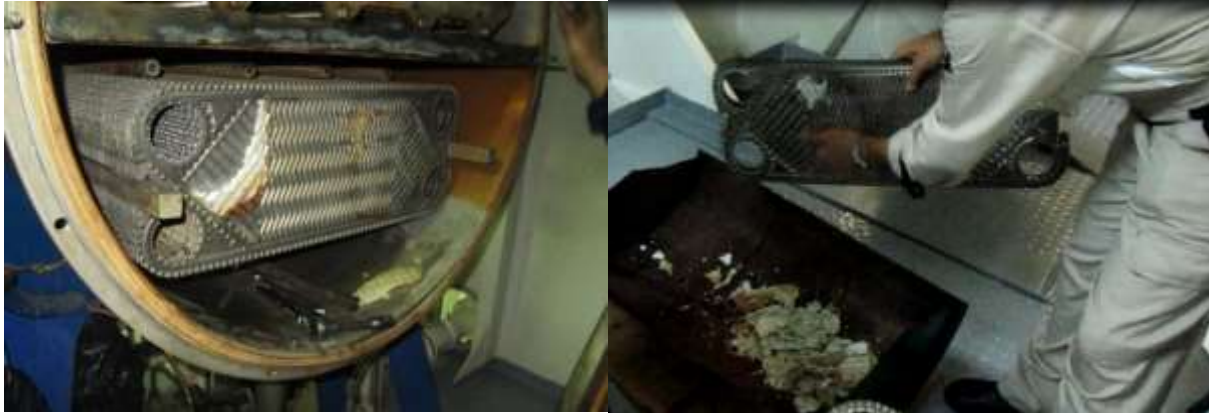
Figure 9.Some plates had limescale on them, but it was easily removed by hand

3. Most of the plates were perfectly clean. A few plates had areas of limescale buildup on them, with a certain pattern (see explanation below), but this lime scale was very loose and was easily and smoothly removed by a hand touch.

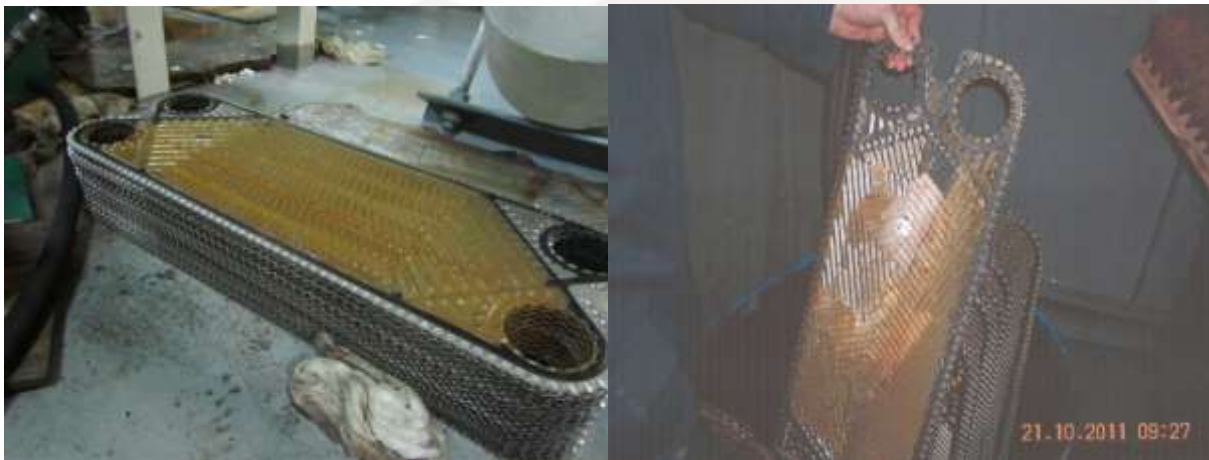
Figure 10.Left: December 2012 – before installation, plates are covered with slime. Right: FWG plates (different FWG unit) treated with chemicals but covered with limescale and slime.

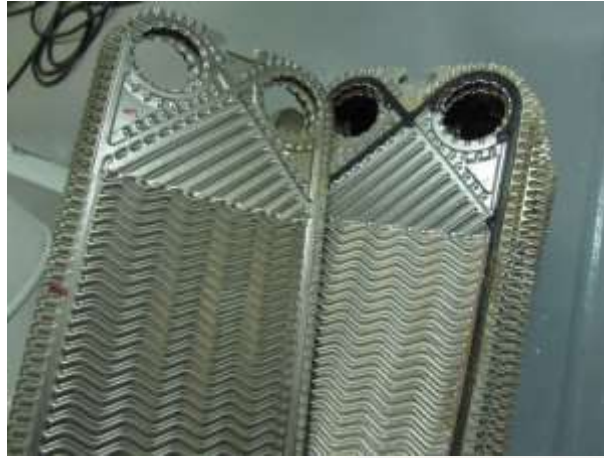
Figure 11. June 2013 – after installation, of the HydroPath MARINE unit the plates are clean.

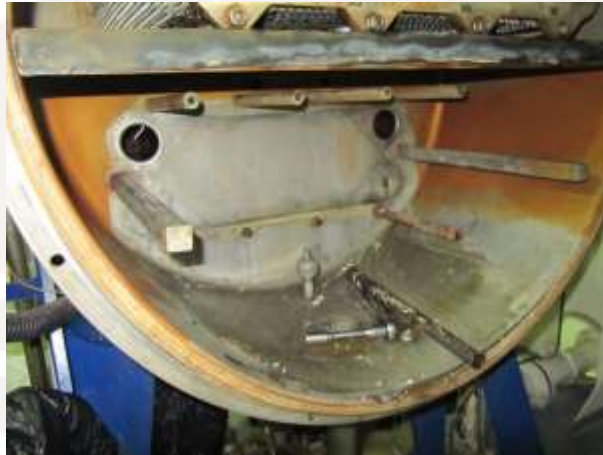
5. The FWG chamber on the sea water side was also clean and contained no limescale, mud or slime.
6. The entire opening, cleaning and closing process, took slightly less than two hours (instead of 24-48 hours).

Figure 12. June 2013 – FWG chamber (where plates are mounted) treated with HydroPath MARINE technology without any limescale or slime.

4. The part of the chamber where the plates were mounted was absolutely clean. The part that was not in touch with the treated water was found with thin mill scale.
